# Sunshine Coast Sediment Transport Pathways

Specks of Sand | 13 May 2017

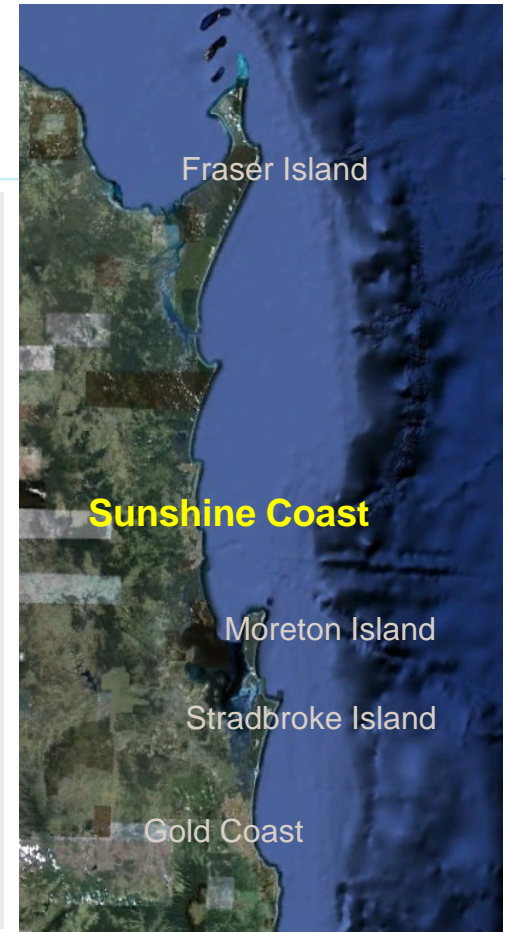
# Regional sediment transport pathways

- Northern NSW rivers have supplied the modern-day (Holocene) sands to SE Queensland beaches and sand islands
- Sand moves in a net northerly direction, approx. 500,000 m<sup>3</sup> annually bypasses the Tweed River Entrance
- The Sunshine Coast is somewhat disconnected from this major sand transport pathway
- Southern Sunshine Coast beaches characterised by a different type of sand (mostly older Pleistocene material)

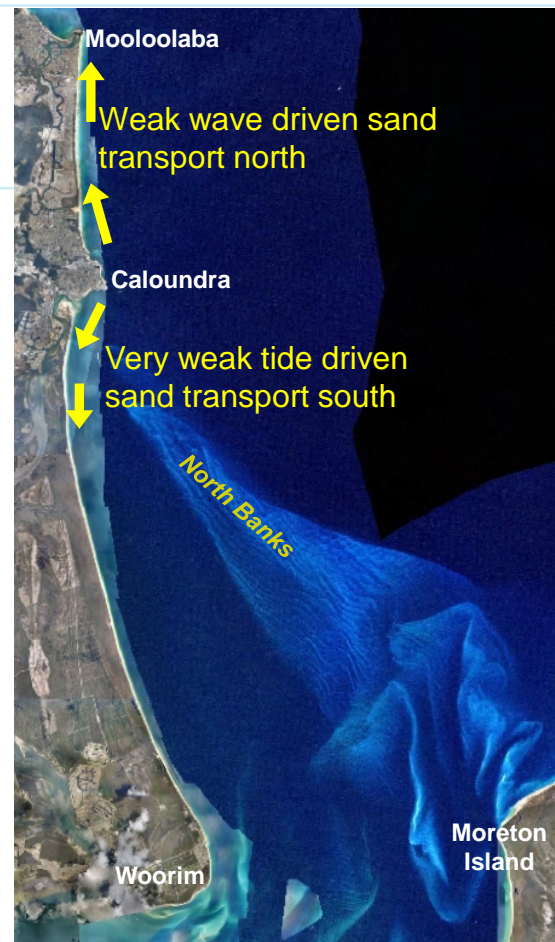
# Regional sediment transport pathways

- The entrance to Moreton Bay accumulates a large volume of sand, only very minor sand transport across the entrance to Caloundra
- Straight coastal alignment, waves arrive with crests parallel to shoreline, low longshore sediment transport rates along southern Sunshine Coast beaches
- Relatively small sediment budget between Caloundra and Point Cartwright, therefore low supply to Mooloolaba Bay and Maroochydore Beach

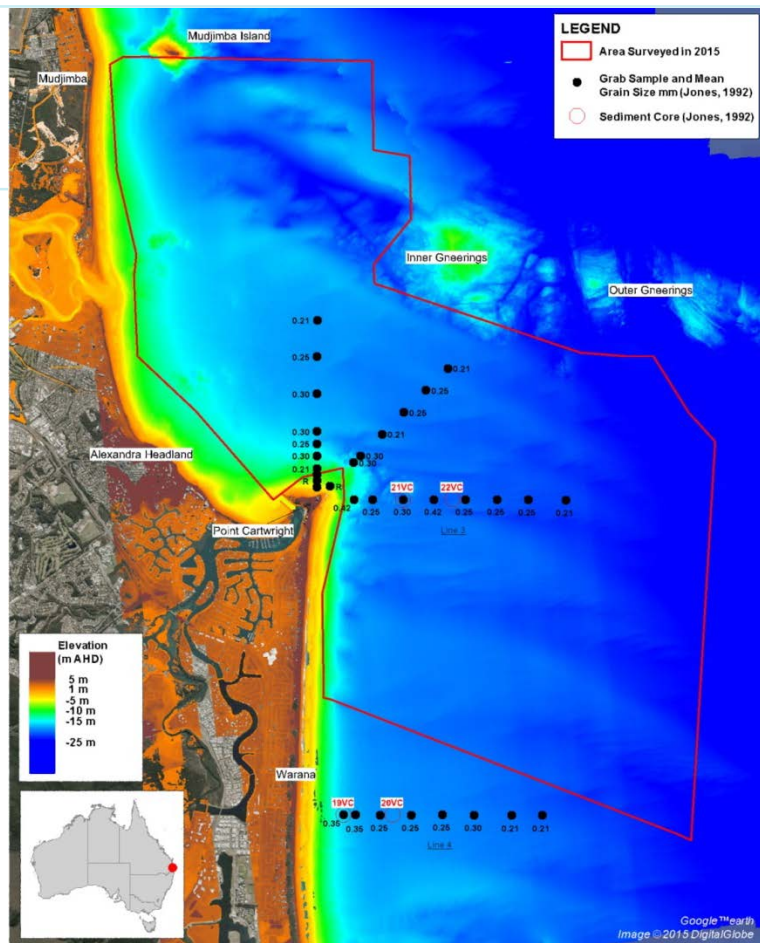
# Local sand budget

- Existing bathymetric LiDAR indicated sandy areas offshore
- Previous sediment coring suggested some areas with deep sand deposits
- Other areas characterised by thin layers of sand above bedrock
- Sub-bottom profiling of offshore area to better understand the volume of local sand deposits

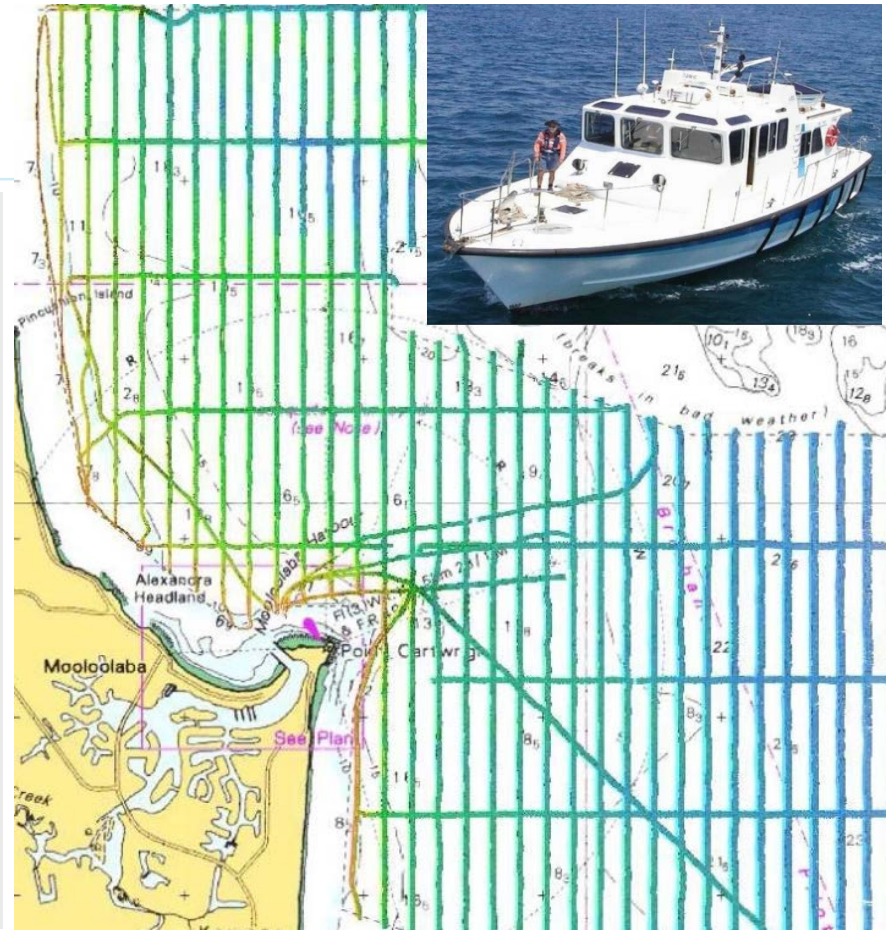
# Sub-bottom profiling

- Work completed by Port of Brisbane (bathymetry) and Acoustic Imaging (sub-bottom profiling) using the Jim Peel survey vessel
- 100% bed coverage not required (and expensive!), lines at approximately 200 m spacing considered suitable
- Sub-bottom profiling able to penetrate sand deposits up to 9 m thick

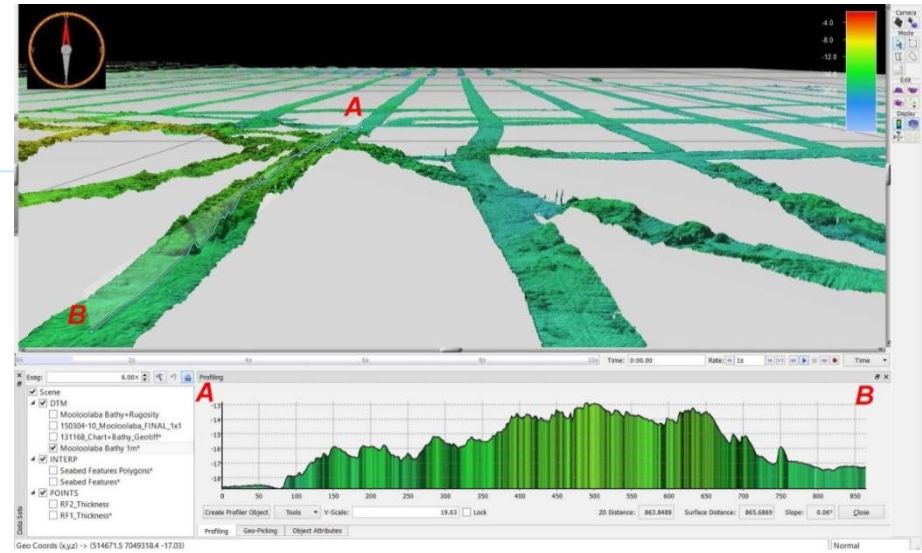
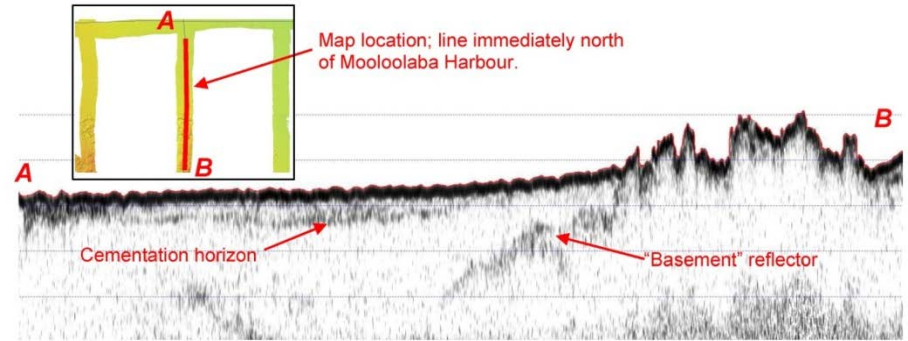
# Sub-bottom profiling

- Bathymetric survey provides details of bed surface
- Able to infer the sand layer thickness based on identification of the “Basement” reflector
- If the Basement reflector signature is not detected sand layer thickness assumed to be >9 m

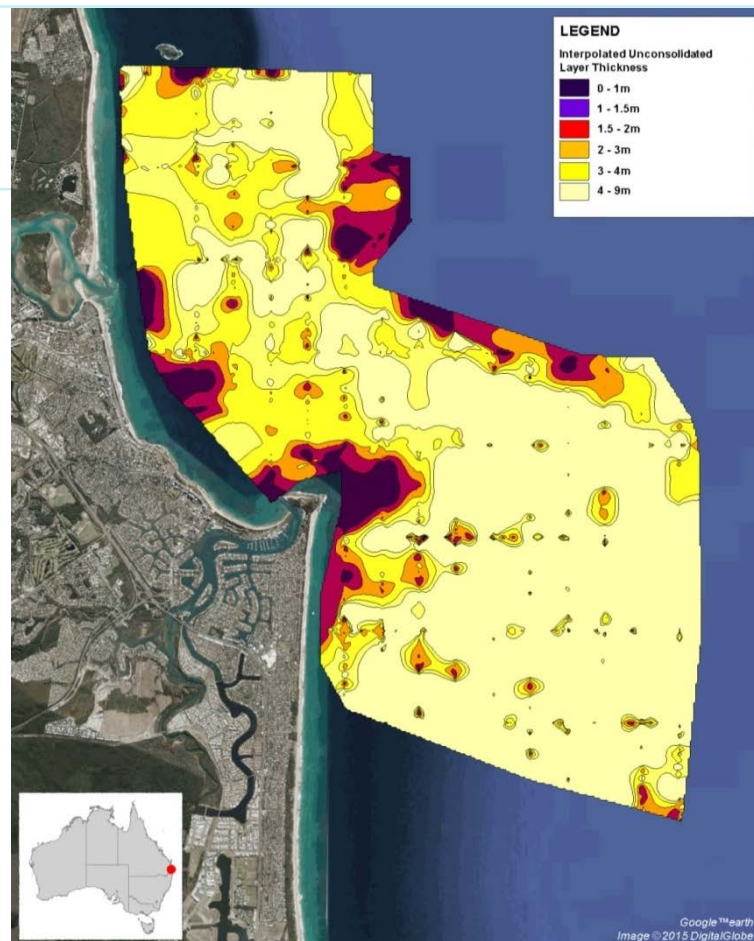
# Sand layer thickness

- Sub-bottom survey results mapped
- Significant sand deposits throughout the southern half of the survey area (>9 m in many locations)
- Generally thin layer of sand (0-3 m thickness) over rock north of Point Cartwright

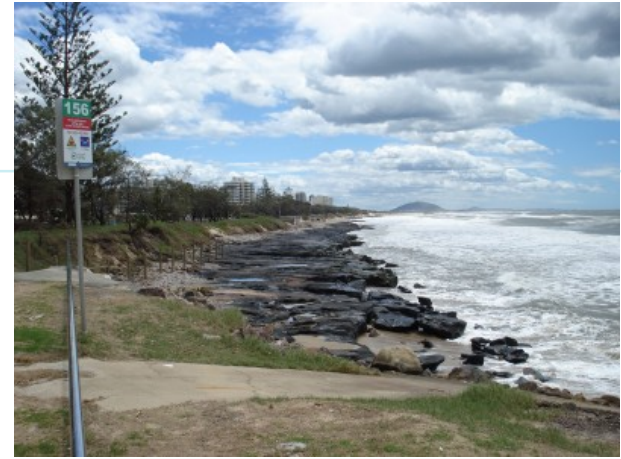
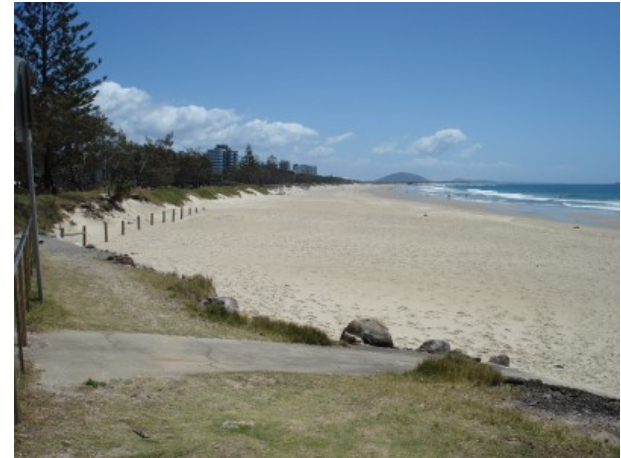
- Beach nourishment is the preferred erosion mitigation strategy – however viable sand sources are limited
- A healthy beach can response to erosion events
- Sunshine Coast recreational, social and economic values dependent on access to healthy beaches
- Proven benefit, delays the need for hard structures

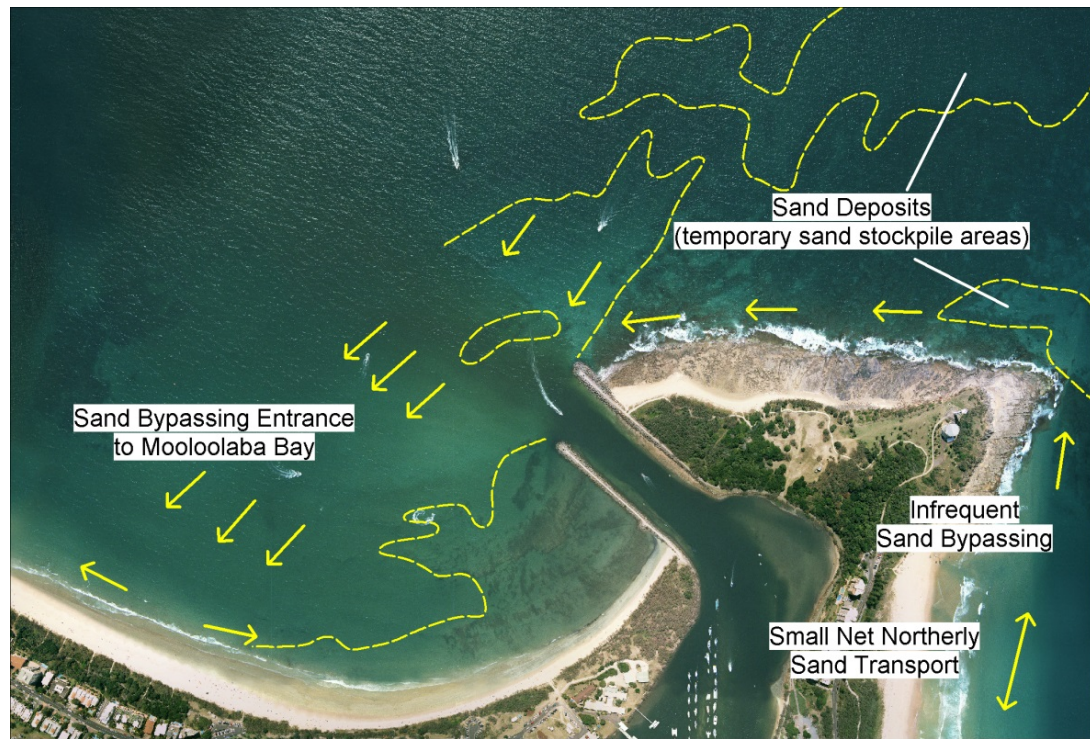
# Point Cartwright & Mooloolaba Harbour Entrance

- Managed by the Queensland Department of Transport and Main Roads (TMR)
- Ongoing monitoring of waves and entrance condition to ensure safe navigation
- Periodic entrance shoaling requires maintenance dredging

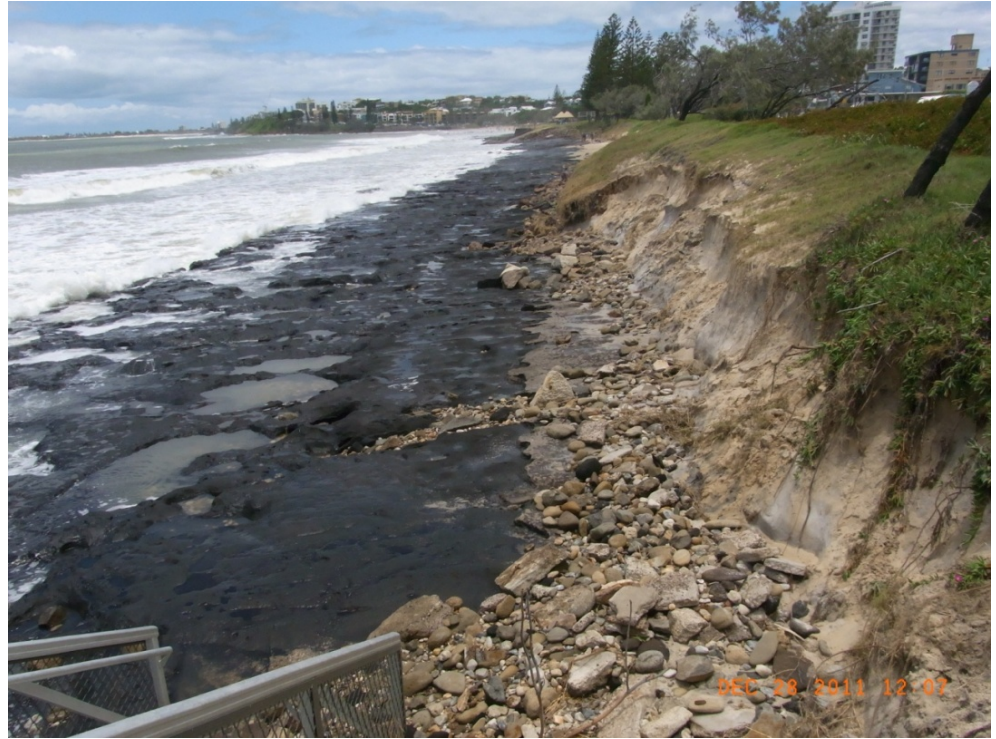
# Maroochydore Beach erosion

- Extended periods without shoaling at Mooloolaba indicates reduced northerly longshore transport rates
- Periods of low transport rates can lead to severe erosion at Maroochydore Beach
- Sometimes maintenance is needed to maintain a healthy beach system

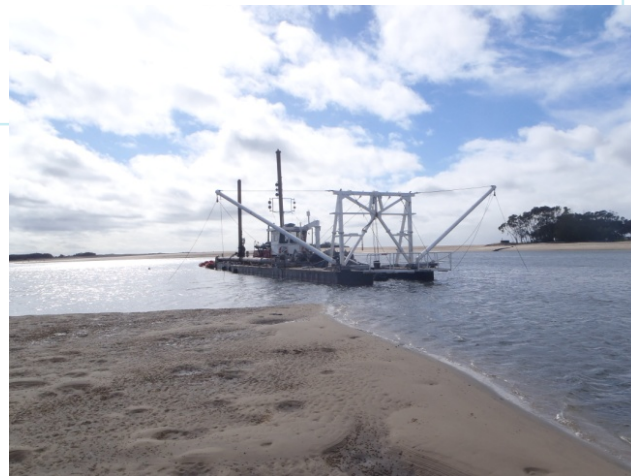
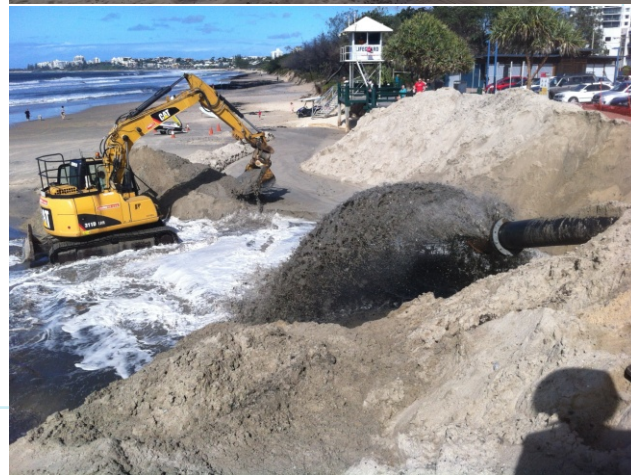
# Maintaining Maroochydore Beach

- Maroochydore Beach Nourishment Project:
  - 125,000 m<sup>3</sup> in 2013
  - 75,000 m<sup>3</sup> in 2015
  - 20,000 m<sup>3</sup> 'top-up' in 2016
- Lower Maroochy River sand borrow area infills at a rate of 50,000 m<sup>3</sup>/year, insufficient sand source over the long term
- Sunshine Coast likely to need additional sand sources to mitigate erosion associated with sea level rise
